Newfound News

North Carolina Clean Water Management Trust Fund

Newfound Creek Watershed project, funded by the Clean Water Management Trust Fund, is going strong! As of July 2005, \$303,368.26 has been committed on Best Management Practices to improve water quality in Newfound Creek. Projects have included access road stabilization, erosion control on urban areas, stream protection systems and streambank stabilization projects.

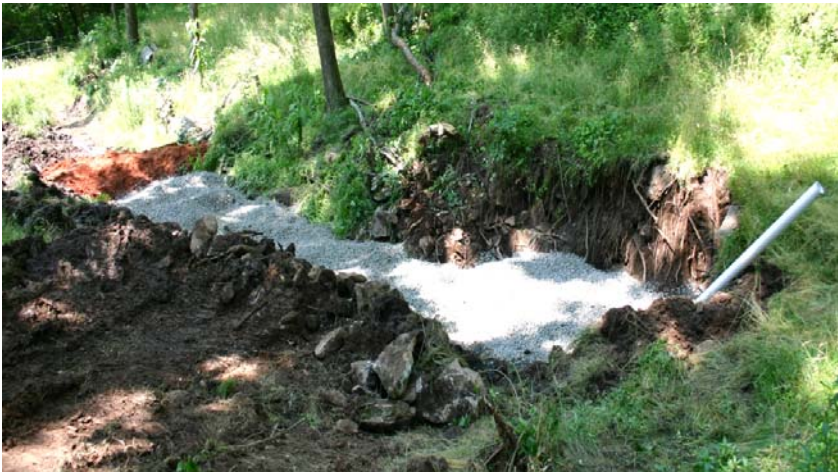
The beef cattle farm featured in this month's newsletter has several Best Management Practices installed on his farm. We started first with a **spring development (top left)** that taps into fresh water high on the mountain and pipes it into four **concrete watering tanks (top right)**. The outlet of the last tank will go back into a neighboring branch. Newfound Project provided 100% Cost Share for the landowner in return for livestock exclusion, a 30 foot setback on both sides of Newfound Creek and a permanent conservation easement. We also helped repair his streambank along Newfound Creek. It was severely damaged from livestock access and heavy flooding. Below are pictures of in-stream structures that are necessary to control stream grade by slowing down the velocity of the water against the banks. Structures such as J-Hooks, Cross-Vanes, and Bankfull Bench are used to prevent further erosion on unstable slopes. These rocks are individually placed to specific angles using natural stream channel design methods from Rosgen techniques and Natural Resource Conservation Service engineers. We installed three **J-Hooks (bottom left)**, two **Cross Vanes (bottom right)** and one Bankfull Bench on site. Please call us at 828-250-4785 to learn more.
